MICROSCOPIC EXAMINATION OF STEEL

HENRY FAY, Ph. D., D. Sc.

*Professor of Analytical Chemistry, Massachusetts Institute of Technology
Consulting Metallurgist, Watertown Arsenal*

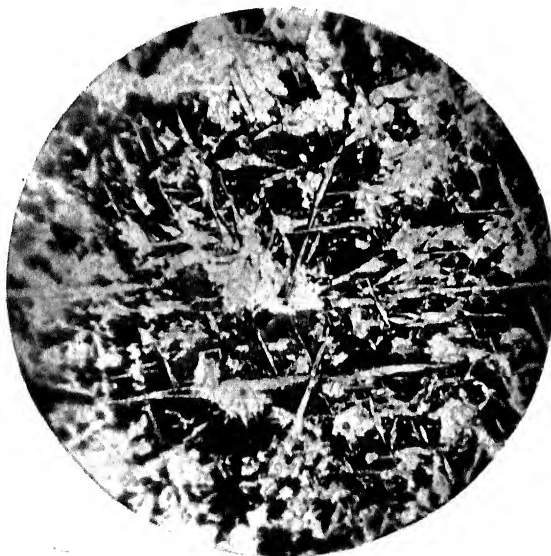
PHOTOGRAPH NO. 51. X50.

Fourteen-inch gun lever. Crystalline structure.

The metal has not been annealed in such a way as to remove the original crystallization which took place at the time of solidification. The crystalline structure is shown in photographs Nos. 50 and 51. Proper annealing should have completely wiped out all appearance of this kind. Evidence of this crystalline nature was found in all specimens examined, and it is highly

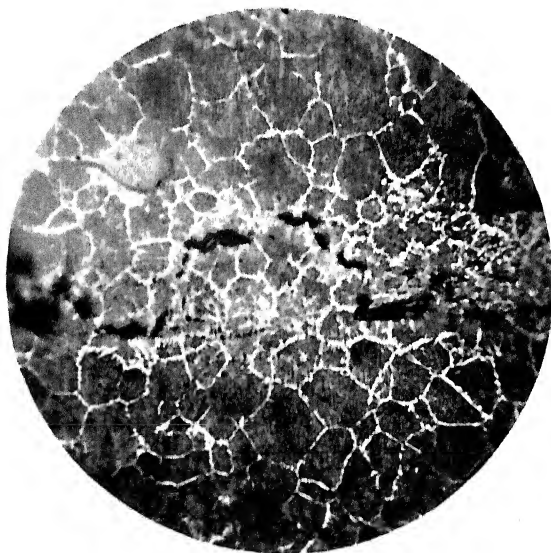
PHOTOGRAPH NO. 53. X50.

Twelve-inch gun. Microstructure showing slag and fissures.

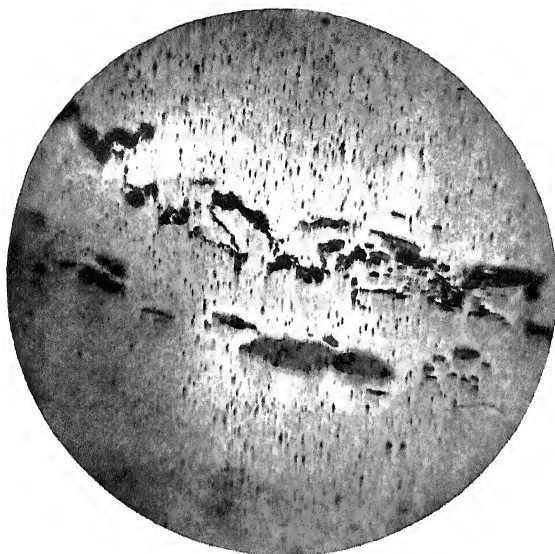
PHOTOGRAPH NO. 54. X50.

Twelve-inch gun. Slag in unetched specimen.

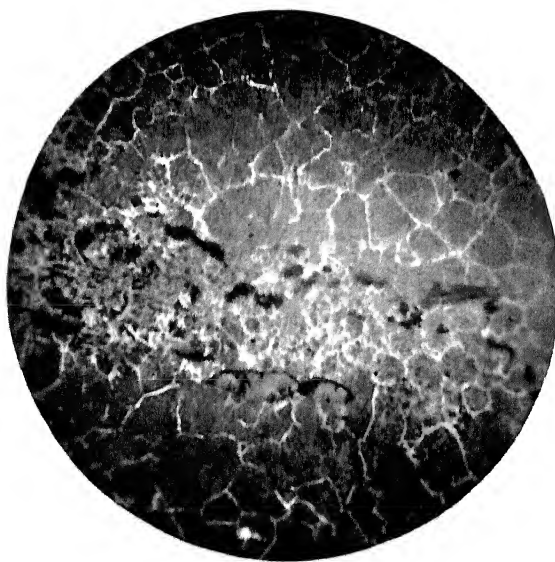
PHOTOGRAPH NO. 55. X50.

Twelve-inch gun. Same area as No. 54, etched with alcoholic nitric acid.
